Zeta P2 problem diagnosis

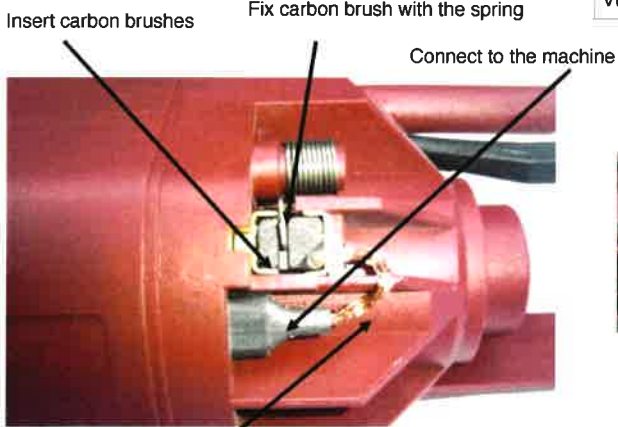
1. Changing the carbon brushes

Make sure the cable doesn't lie on the sharp edge
Carbon brushes should move easily in the bracket

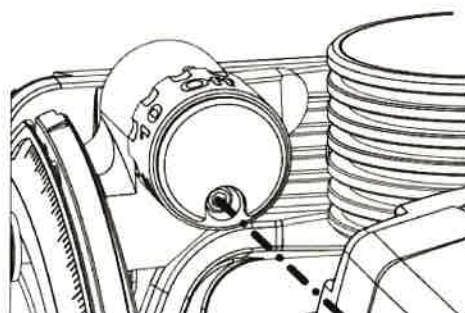
3. Push VMD button to check function
